# AN OVERVIEW OF THE REPAIR, EVALUATION, MAINTENANCE AND REHABILITATION (REMR) RESEARCH PROGRAM 1984 - 1989

March 1990

Final Report

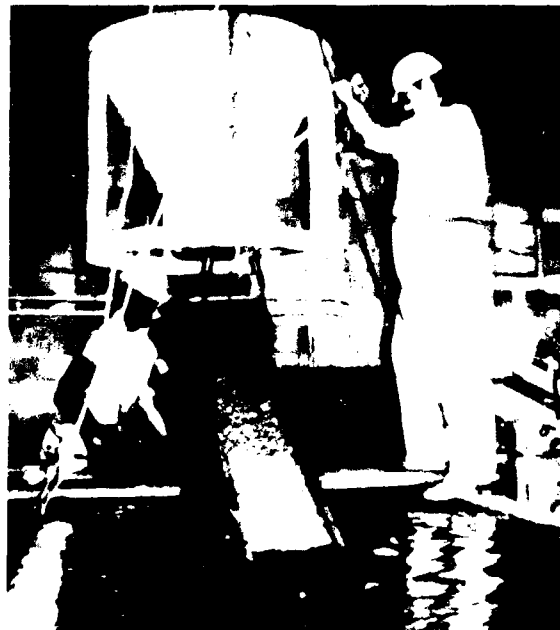
Figure 5. Laboratory test of underwater concrete mixture using an inclined tremie..

Concrete mixtures were developed in the laboratory using these new admixtures to minimize the reduction in concrete quality that is normally associated with the placement of concrete underwater. In addition, several repair concepts (e.g. use of precast elements) and various underwater concrete placement techniques (e.g. inclined tremie, pumping, etc.) were identified.

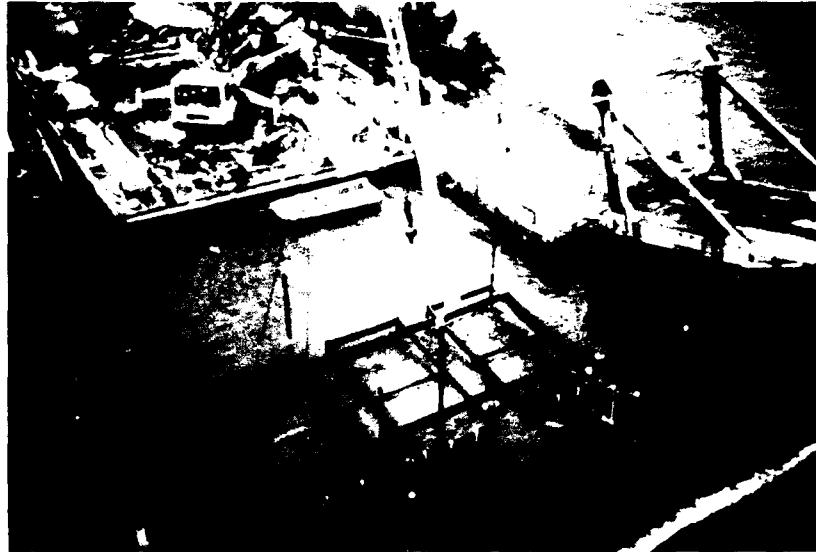
Figure 14. Grout-filled fabric bags being used to repair a scour area at Emsworth Dam.

Corps districts can use this information to design an economical and functional scour protection plan for the remainder of a project's life. A good scour protection design will reduce and possibly eliminate maintenance costs previously required. Some of the repair techniques investigated under this study have been used at Emsworth, Montgomery, and Dashields Dam, Ohio River, at Lock and Dam No. 2, Monongahela River, and at Lock and Dam No. 7, Allegheny River.

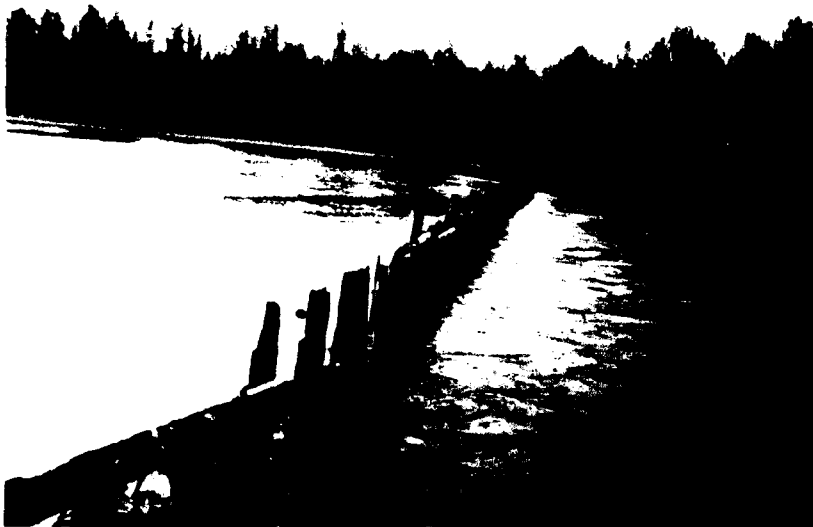
Figure 16. This training structure on the lower Columbia River was one of those identified as no longer needed.
